Manhole Inspection Summary

Manhole # S41E__062MH

Insp Date: **7/25/08 11:56 AM**

Location Address: **1121 e baltimore st**

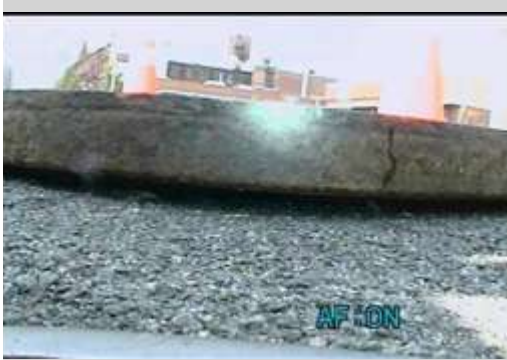
Defect 3

Condition: **Cracked**

cracks in cover

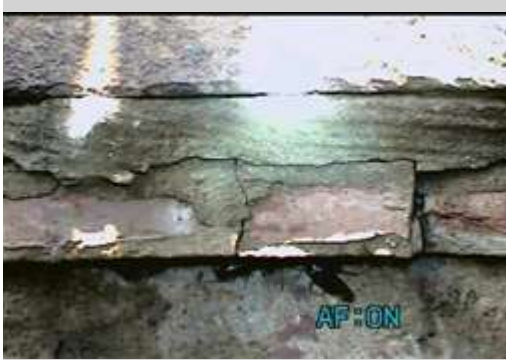
Defect 2

Condition: ☐ Sound ☐ Cracked ☐ Root Intrusion ☒ **Loose Brick** ☒ **Deteriorated**

frame adj

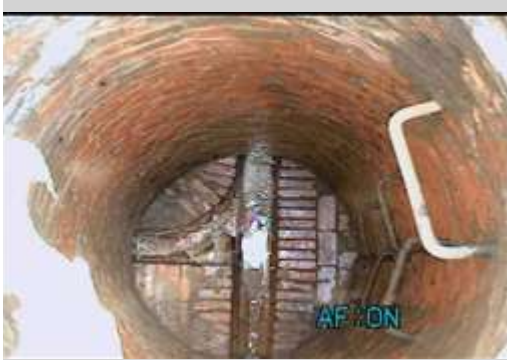
Defect 4

Count: **6** Missing: **0** ☒ **Corroded**

corroded steps

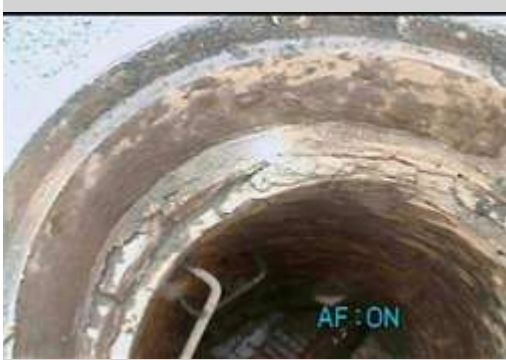
Defect 1

Offset: **3** (in.)

offset

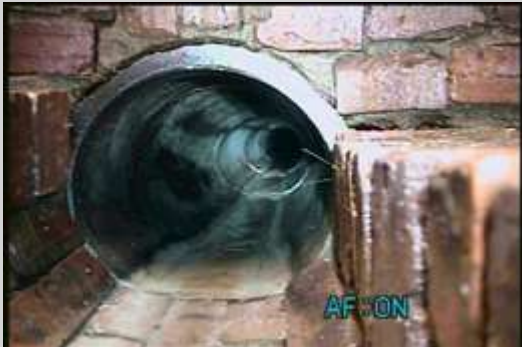
12 O'Clock Outflow

10 in. Circular Gravity Sewer
Pipe Out @ 12 O'Clock

Pipe Material: **Clay** ☐ Pipe Lined

Invert Depth: **10.82** (ft.) Flow Characteristics: **Slow**

Infiltration: **None** Pipe Seal Cond: **Unknown**

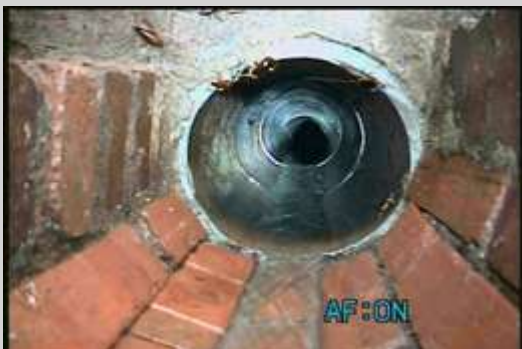
6 O'Clock Inflow

8 in. Circular Gravity Sewer
Pipe In @ 6 O'Clock

Pipe Material: **Clay** ☐ Pipe Lined

Invert Depth: **10.70** (ft.) Flow Characteristics: **Slow**

Infiltration: **None** Pipe Seal Cond: **Unknown**

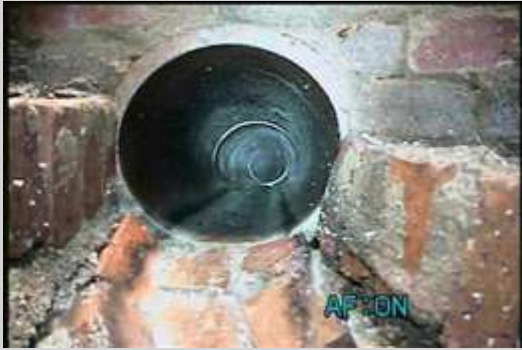
9 O'Clock Inflow

8 in. Circular Gravity Sewer

Pipe In @ 9 O'Clock

Pipe Material: **Clay** ☐ Pipe Lined

Invert Depth: **10.20** (ft.) Flow Characteristics: **Slow**

Infiltration: **None** Pipe Seal Cond: **Unknown**
